Cleaning the Laundries II. Report of the 2007 campaign

Miko Flohr

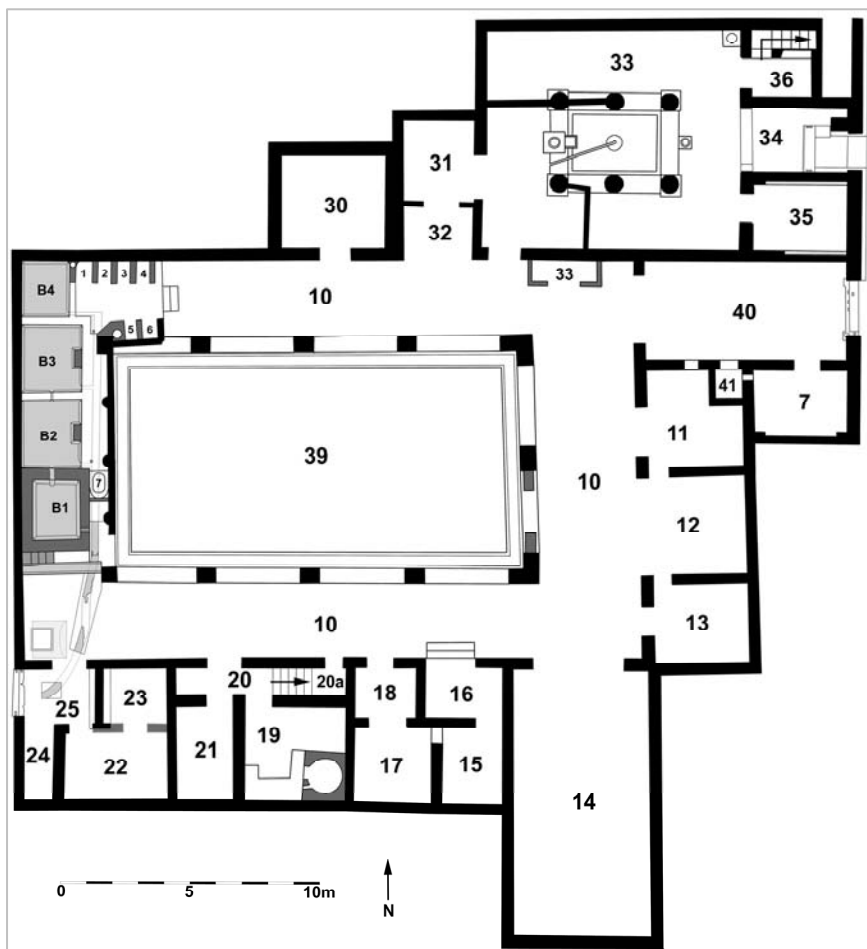
Fig. 1. Pompeii, house VI 8, 20-21.2, Plan.

This complex, which was excavated in 1825, consisted of a small *atrium* and a vast peristyle with residential and utilitarian rooms along its east and south sides (Fig. 1). The main working area of the *fullonica* occupied the entire west portico of the peristyle and a small part of the north portico. It was divided into two parts: the northeastern part contained six of the typical 'treading stalls', where clothes were soaped in, whereas the west wing was occupied by four basins that were used for rinsing. In the period after the excavation, the ancient floor layers were gradually covered by sand and debris everywhere in the house. This was particularly the case in the workshop, where, for example, the rinsing basins were partially or completely filled up. This all made it hard to understand the functioning of the *fullonica*, especially since many relevant details were not recorded by the excavators or later investigators, such as Fox, who produced a detailed map of the workroom in the 1880s (Fox 1905, Pl. LIII). There were several problems that could only be solved by surface cleaning:

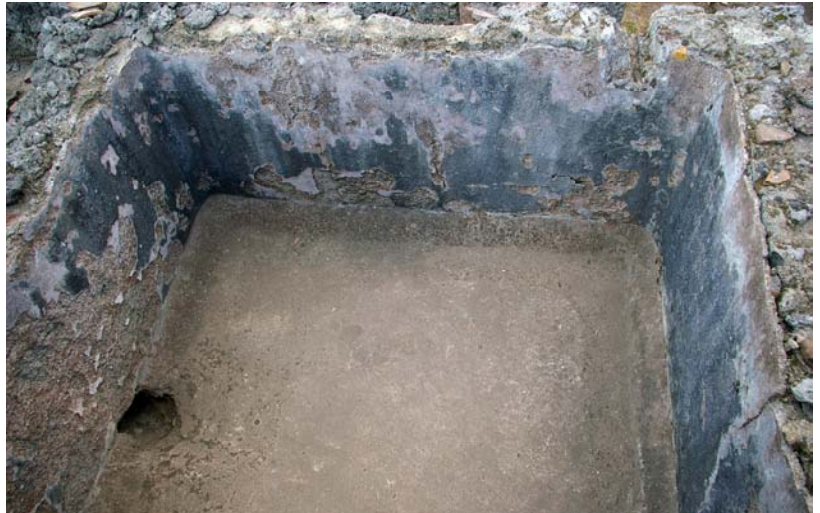
The rinsing complex consisted of three basins (B1, B2 and B3), whereas a fourth basin was attached to its north side. The floor and the walls have been lined with waterproof plaster and all corners and angles have been strengthened with the usual rim. B1 is surrounded by high walls and has a floor on a higher level than that of the other two (Fig. 2). With a surface of 4.45 square meters and a maximum water level of 95cm it could contain about 4100 liters of water. The basin was fed with fresh water through a lead pipe. While no remains of the pipe itself have been discovered, its imprint can be found in a small depression in the east wall of the basin, near the SE corner (Fig. 3). The mouth of the pipe was surrounded by a square or rectangular piece of lead, of which the imprint remains on the inner wall of the basin. The outer diameter of the lead pipe was only 4 cm. As the basin did not have an overflow, there cannot have been a continuous flow of water and a tap must have been used to regulate the inflow. This might have been situated on top of the east wall. The basin could be emptied through a drain in the north wall, which opened onto B2. While the hole of this drain is intact, no remains of a terracotta or lead pipe have been preserved and it is not possible to reconstruct how the drain was closed off and opened. Though the basin itself was not easily accessible, it could be approached from the south side by four steps, from the top of which about half of the basin was within an arm's reach.

Fig. 2. Pompeii VI 8, 20-21.2, fullonica: basin B1, overview.

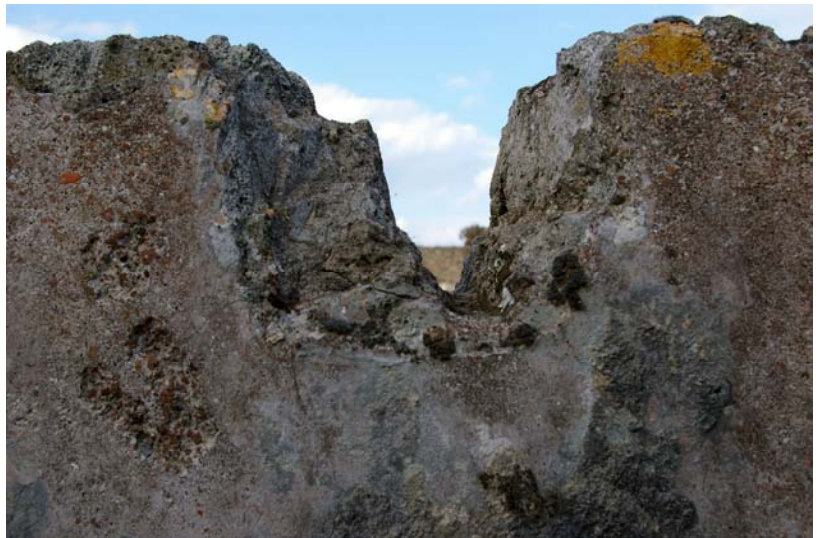
Fig. 3. Pompeii VI 8, 20-21.2, fullonica: basin B1, mouth of the water supply in E wall.

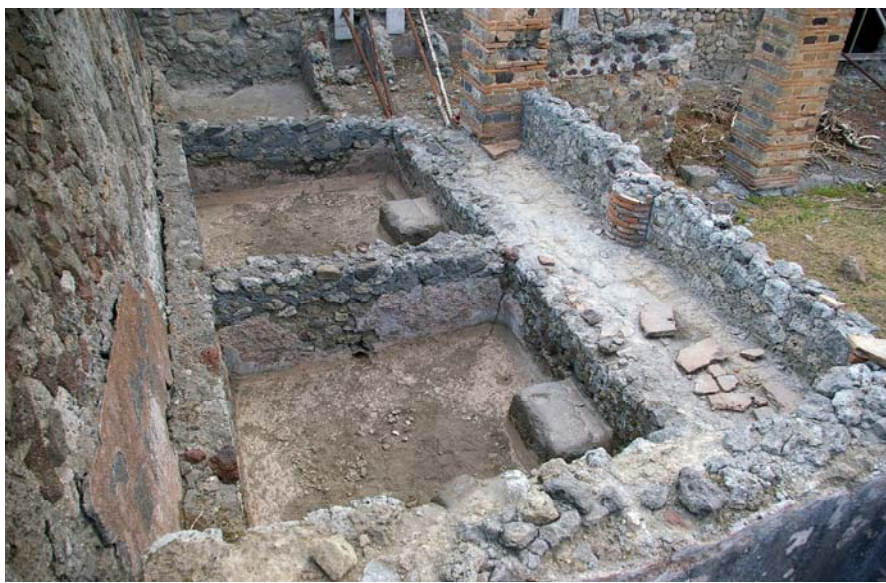
The other two basins had a slightly larger surface of 6.10 square meters but a considerably lower maximum water level (Fig. 4). With a depth of 60cm, they each had a capacity of about 3500 liters. However, as

there neither of the basins has an overflow, we do not know to what level these basins usually were filled, but it may be guessed that the most common level was about $1\frac{1}{2}$ 'R or 44.5cm. The floors of these basins were less well-preserved than that of B1: the top layers had only been preserved along the side walls and in the center of the floor, even the lower layers were found heavily disturbed. Along the west side of both basins, modern walls have been built, probably to stabilize the *opus quadratum* west wall, which strongly leans to the west and is nowadays shored up by metal buttresses on the street. In antiquity, the west wall of the house also functioned as the west wall of B2 and B3. Both basins were accessible from the work floor east of them by means of a step made of a basalt block, the irregularities of which were filled up with waterproof plaster. For their water-supply, B2 and B3 were dependent on B1, which suggests that the water from this basin might have been reused in the other two. However, a completely filled B1, when emptied into the lower basins, would be able to fill both basins only to a height of 35,5cm,

Fig. 4. Pompeii VI 8, 20-21.2, fullonica: basins B2 and B3, after cleaning.

which is only just above the level of the steps. Hence, it is likely that the used water from B1 was supplemented with a certain quantity of fresh water directly from the lead pipe. While the two basins were connected by a terracotta pipe in the wall between them, each had its own drain, in both cases in the southeast corner. In B2, this drain was made of two *imbrices* put on top of each other, while in B3 a terracotta pipe was used.

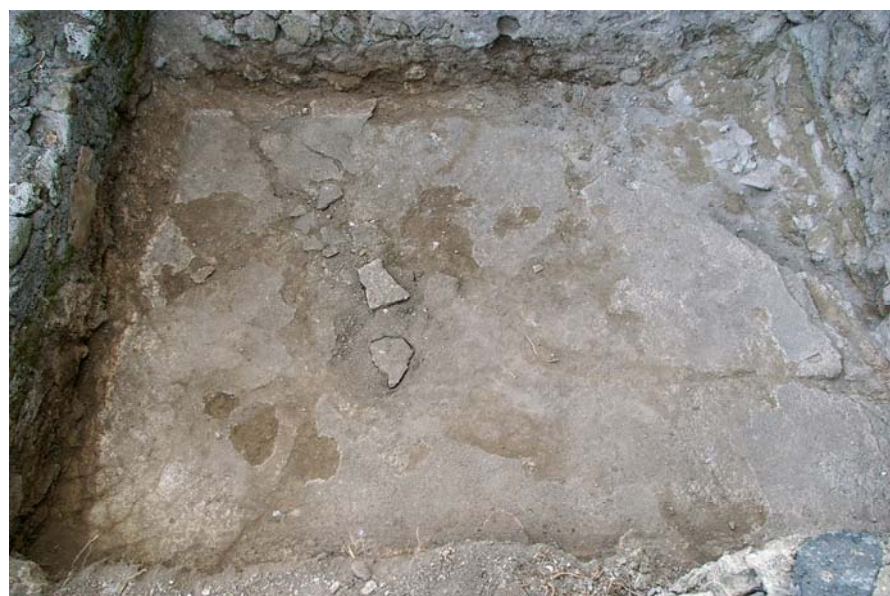
Fig. 5. Pompeii VI 8, 20-21.2, fullonica: basin B 4, overview.

North of B3 was a fourth basin which was not connected to the complex of rinsing basins (Fig. 5). It has a surface of only 3.49 square meters. As the surrounding walls have not been preserved, the height and thus the capacity of the basin are unknown. The floor was on a considerably higher level than that of B2 and B3 and not much lower than that of the area of the fulling stalls. There was a drain in the southeast corner made of two *imbrices* put on top of each other. The floor of this basin clearly slopes into the drain. Remarkably, there are no traces of a lead pipe or other means of filling the basin with water, which suggests that the amount of water used here was fairly limited and the walls of the basin might have been relatively low. The nature and function of the basin is not entirely clear, but it seems unlikely that it was used for rinsing.

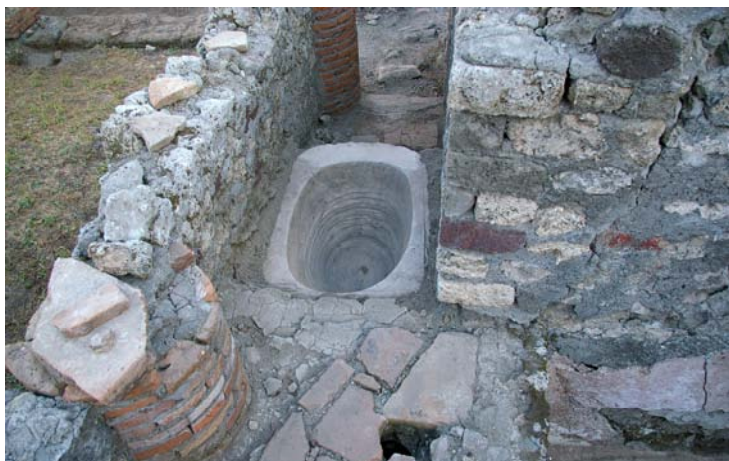
carved out. Similar treading stalls can be found in the *fullonica* of Stephanus. The stall was on the same level as the passageway east of B2 and B3. In front of it was a hole in the floor that was connected to the drain. The floor on the south side was on a lower level and on Fox' map, a wall appeared at the south side of the stall, which indicates that the stall was only accessible from the north. S7 was thus situated in a position remote from the other stalls and seems more related to the complex of rinsing basins. This may also suggest that it had a function that was somewhat different from that of the other stalls and that it played a role only after the clothes had passed through B3 and B2 and thus had undergone the first and most thorough phase of rinsing. Departing from this assumption, two possibilities emerge. One is that the clothes were inspected and, if necessary, were soaped in again and sent back to B2 and B3. The other option is that the clothes would need an additional treatment with some chemical agent, after which the clothes passed to B1 for the final soaking. Given the fact that there was only one stall for this purpose, it is likely that this treatment did not cost much time or did not involve all clothes. There are two parallels for this stall. One is in the *fullonica* of the Via degli Augustali at Ostia, where two fulling stalls have been built on the wall between the second and third basins of the rinsing complex¹. The other is the *fullonica* at Fréjus, where a separate

In the narrow corridor E of basin B1, the expected seventh fulling stall was found (Fig. 6). It actually was a block of travertine in which an oval basin (Ø 46.5-73cm, depth 41cm) was

Fig. 6. Pompeii VI 8, 20-21.2, fullonica: travertine fulling tub S7.

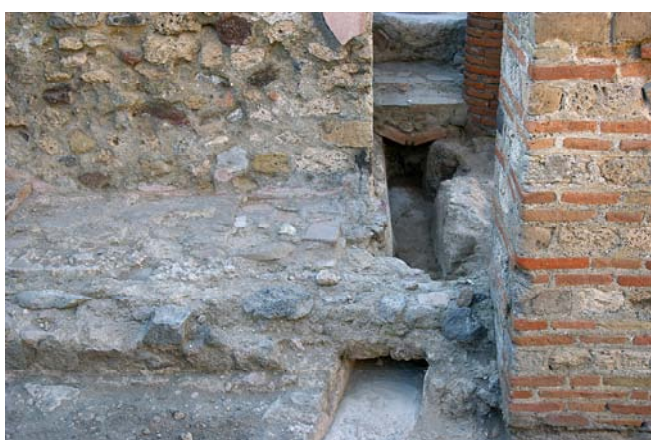
Fig. 7. Pompeii VI 8, 20-21.2, fullonica. Drain, northern part.

The discharge systems of B2, B3 and B4 and of the area of the fulling stalls suggest that all water from the various parts of the workshops must have been collected in one drain and that this drain must have run east of the two basins, underneath the podium. Parts of this drain have been found at four spots: in the corridor E of basin B1, south of S7 (Fig. 7), near the door between portico 10 and room 25, in room 25 (Fig. 8) and in the sidewalk in front of entrance VI 8, 2 (Fig. 9). It ran in a straight line directly next to the rinsing complex in southern direction. South of B1 it bore slightly to the west in the direction of the door to room 25 (see map, Fig.

Not all parts of the drain were found undisturbed. The first part, next to B1, was in a good state. The width of the canal was here, at the bottom, 16cm and it was 33cm deep. The west wall was completely intact, but parts of the east wall had disappeared. The northern half of this part of the drain was filled in with sand and rubble, but the southern half, where the east wall was no longer extant, had been partially filled up by a modern restoration. On the bottom of the canal, pottery sherds were found, mostly of coarse pots and jars, but there were also some fragments of finer pottery, including Pompeian red-ware (Fig. 10). At the

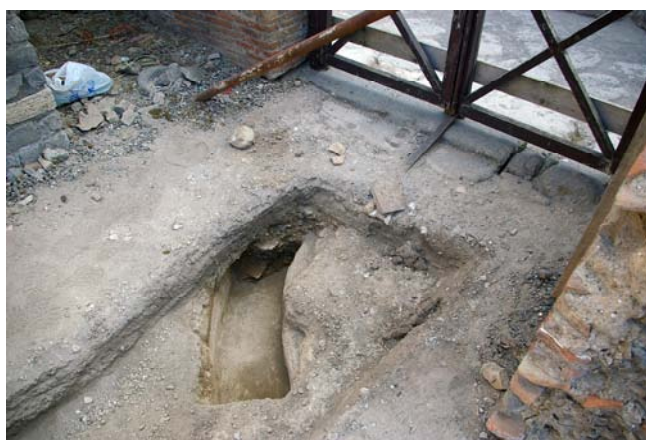
Fig. 8. Pompeii VI 8, 20-21.2, room 25: drain from fullonica.

probably the remains of several amphorae. In room 25, which had a much higher floor level, the canal was found relatively undisturbed, even though the ancient floor of the room is no longer extant. Its width was 27cm and it was 17cm deep. Walls and floors were intact, but no traces of a covering were found. The canal was completely filled up with sand and debris, in which a lot of pottery was found (Fig. 13). Again, this was mainly coarseware, including several sherds of amphorae with remains of a white, limy substance. Finer pottery included the remains of a small pot and some Pompeian red-ware.

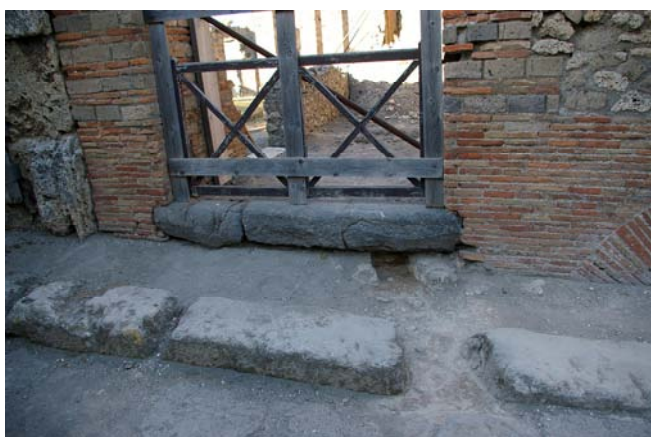
Fig. 9. Pompeii VI 8, 20-21.2, back entrance 2: drain from fullonica.

1). Shortly before this door, the drain began to curve further to the west towards the back door of the house. Passing under the threshold it made a turn to the south so that the wastewater would approach the street with an angle of 45° and would flow away in the right direction without using more of the street than strictly necessary.

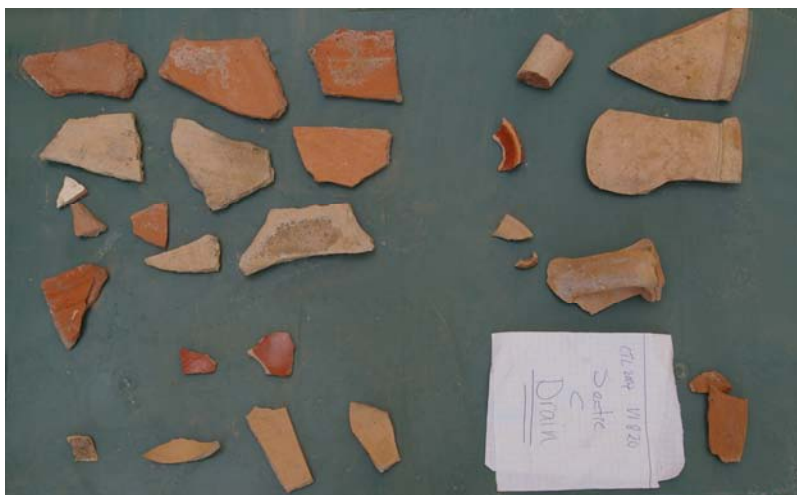
Fig. 10. Pompeii VI 8, 20-21.2, fullonica: drain, pottery ensemble from section A.

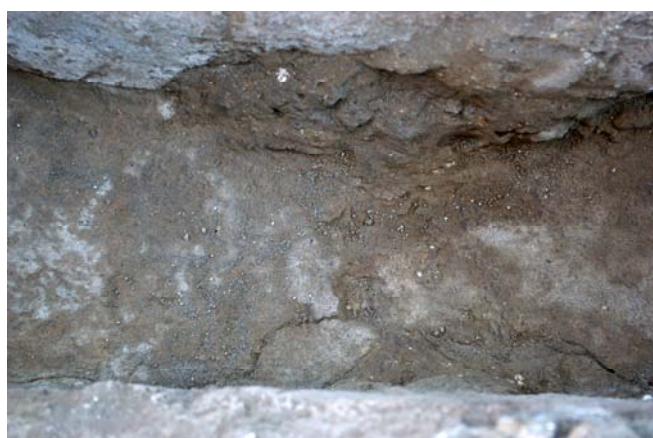
height of the south end of the basin traces were found that point to the presence of a filter (Fig. 11). They consist of limish sediments along the two sides of the drain and two small fixing holes in the bottom. South of the working area, in the portico, preservation circumstances were worse. The canal was with 27cm slightly wider, but its height cannot be reconstructed. Except for the parts near the working area and the door to room 25, the walls and the floor of the drain have been completely eroded away. Again, the fill of the canal contained a lot of pottery, particularly in the part near room 25 (Fig. 12). This ensemble included little diagnostic material, but consisted exclusively of coarse ware,

Fig. 11. Pompeii, fullonica VI 8, 20-21.2, work room, drainage channel next to basin B1. Traces of filter.

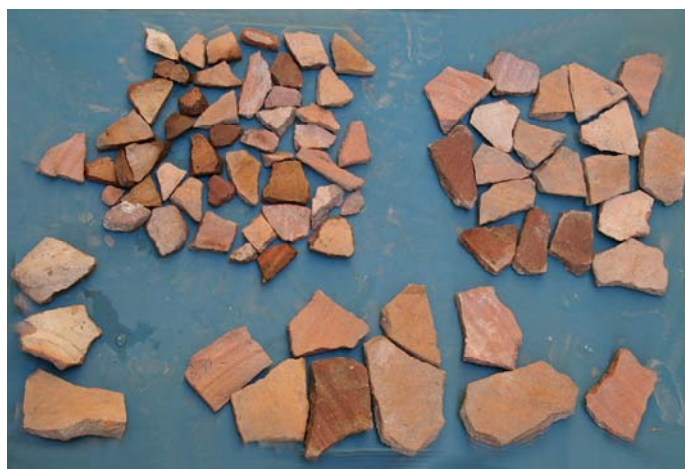
Fig. 12. Pompeii VI 8, 20-21.2, fullonica: drain, pottery ensemble from section B.

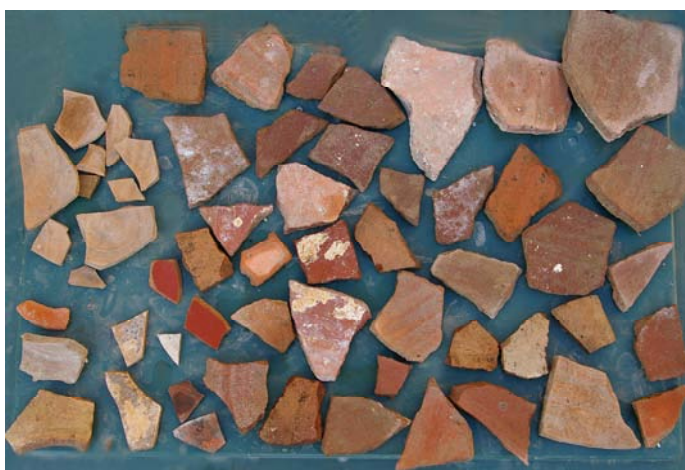
Fig. 13. Pompeii VI 8, 20-21.2, room 25: drain, pottery ensemble from section C.

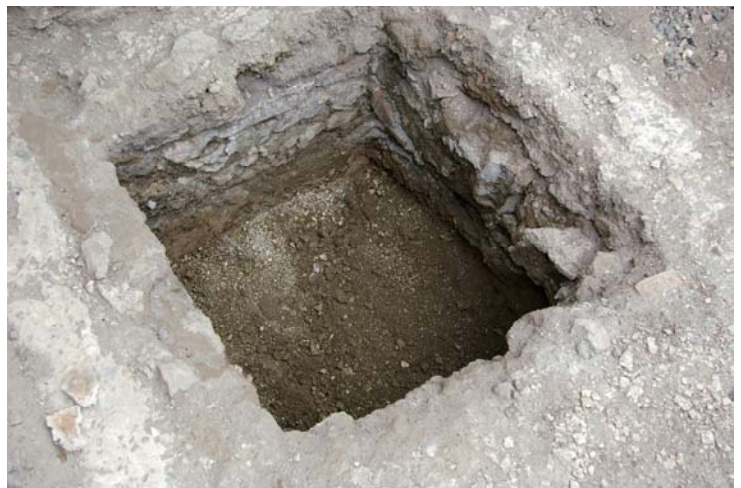
and consisted of a square area of about 70x70cm, the surface of which was covered with fragments of roof tiles, *imbrices* and other coarse materials (Fig. 14). Around the area, the top layer of the original peristyle floor of white marble with polychrome decoration is preserved over a width of about 10cm. The fill of roof tiles was removed and revealed a square hole, of which the walls were covered by plaster. The fill did not contain any relevant finds. At a depth of 42cm, a thin layer of sand was encountered, below which were undisturbed *lapilli*. It was decided to leave these unexcavated.

It turned out that the square hole was a shaft giving access to a vaulted cistern or a small subterranean room that was not excavated in the 19th century. At a depth of 45cm, the plaster of the north and south sides curved outwards. Traces of a vault construction could be seen in the east wall. Below this, it was possible to see the plastered ceiling of the space running away to the east. As the *lapilli* had not completely filled up all the empty space, it was possible to trace the eastern back wall at 58cm from the shaft. Thus, the cistern or room extended north, east and south of the shaft. Its exact size and depth are unknown. It seems that the vaulted space did not belong to the original layout of the peristyle and postdates the original marble floor: the walls of the shaft were built against and partially over it and there are traces of cuts at several spots.

As to the nature of the space, what argues against it being a cistern is the lack of a system of provision and discharge of water: there is neither a connection to the collection system in the peristyle, nor an overflow to get rid of excess rainwater. The alternative, that it was a small room may thus be more probable. Possibly, it was used for cool underground storage for goods used in the workshop or in the house.

Fig. 14. Pompeii VI 8, 20-21.2, porticus 10: SW corner. Shaft giving access to vaulted underground area.

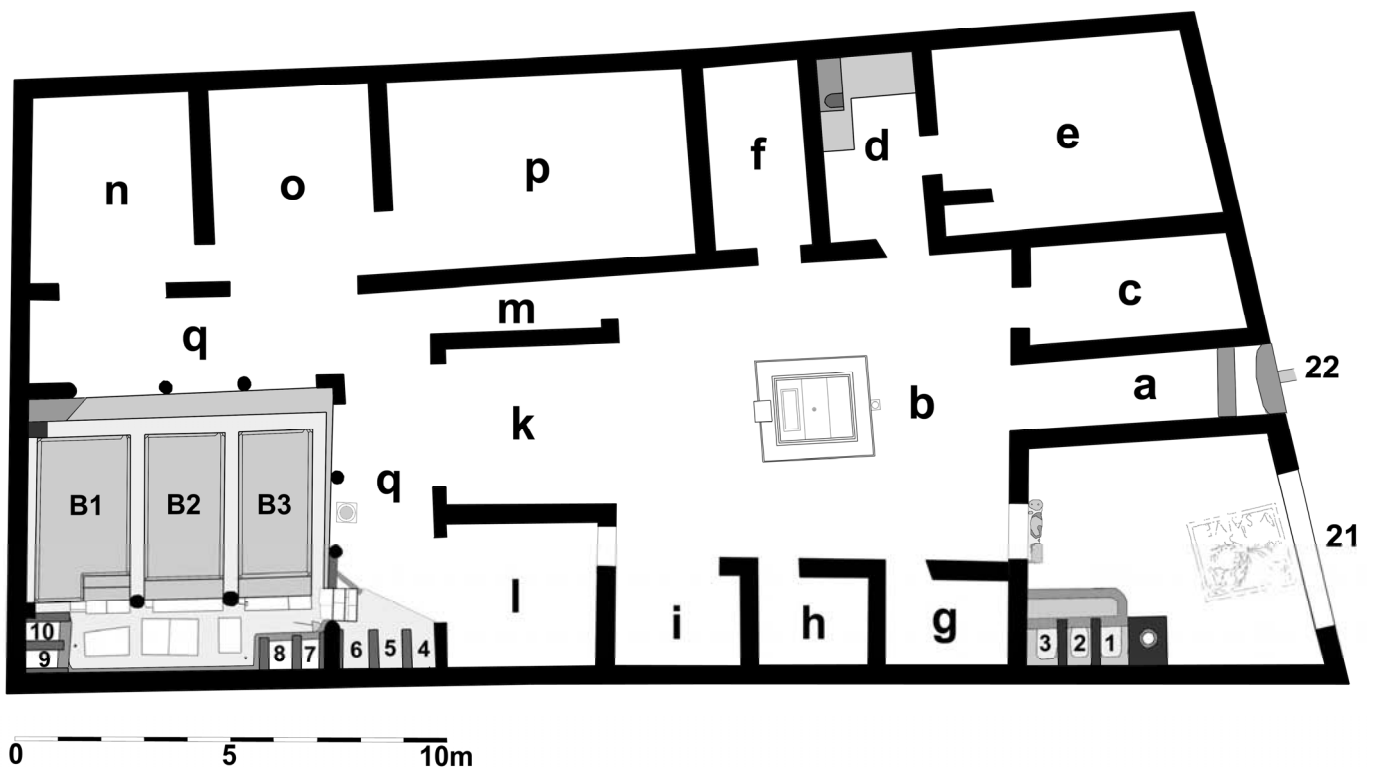
Fig. 15. Pompeii VI 14, 21.22, Plan.

This medium-sized *atrium* house contained a *fullonica*, inserted into the house after it had collapsed due to earthquake damage in the first century AD (Fig. 15). Both the house and the workshop were relatively well-preserved, and much information can be directly derived from the standing remains, especially in the main working

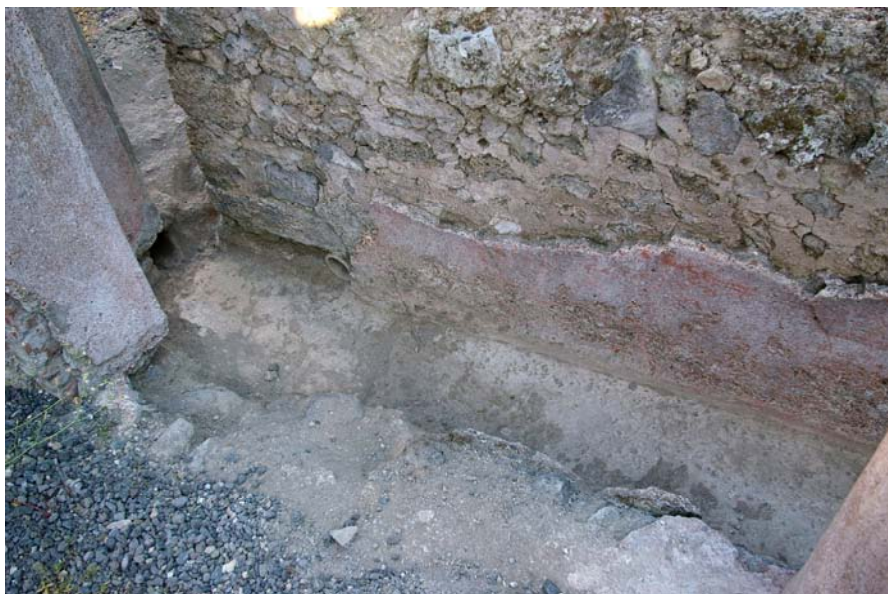
The discharge system of the workshop consisted of two branches. One narrow gutter ran east of the rinsing complex and transported the wastewater from the fulling stalls. Originally, it was used only for the waste from the four stalls on the podium south of the rinsing complex. Later, when the fullery was extended with three new stalls against the south wall of the portico (q), a side branch was added for the wastewater of this area. The second branch, which was much wider than the first, ran north of the rinsing complex and transported the water from the rinsing basins, each of which had a drain connected to it (Fig. 16).

Fig. 16. Pompeii VI 14, 21-22, peristyle Q: collection channel for water from rinsing basins.

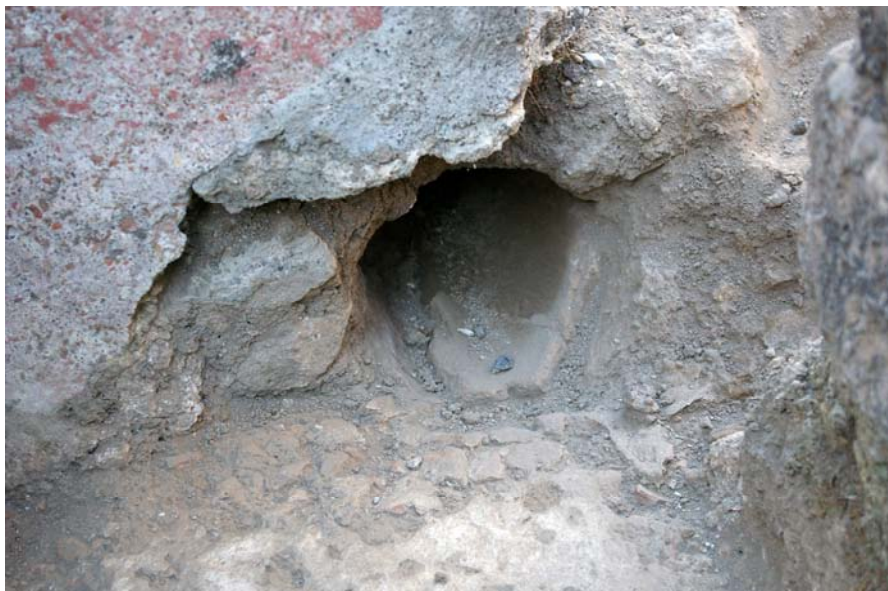
To find out where the entrance to the drain was situated, the two branches of the discharge system were emptied to the bottom and the entrance to the drain was found in the north-east corner of the area, precisely at the point where the two branches merged (Fig. 17). The drain was made of two *imbrices* placed on top of one another and was situated underneath the southern part of the L-shaped *opus latericium* pier that formed the corner of the peristyle. Since this pier is likely to antedate the construction of the *fullonica* and the entrance to the drain antedates the pier, it must indeed be related to a preexisting water system. Probably, it originally indeed had a role in the processing of rainwater and either was connected to the cistern or, if the cistern had a separate inlet at a lower level, it functioned as an overflow for superfluous rainwater. In any case, after the construction of the *fullonica*, the connection with the cistern was closed off and the

Fig. 17. Pompeii VI 14, 21-22, peristyle Q: entrance to underground drainage channel.

wastewater ran directly through the drain towards the *impluvium* and to the street. Apparently, the capacity of the extant drain was enough. Only between the *impluvium*, which got a fountain and thus produced a continuous flow of water, and the street it was necessary to dig a new, larger drain, as is clearly visible in the floor of *fauces a*. The cistern remained in use and was fed by water collected at the gutter on the level of the peristyle roof. It was transported to the cistern through a system of lead pipes.⁵ Thus, there were two separate water systems in the same part of the house. The discovered entrance to the drain in the corner of the peristyle at present is completely open, but it is possible that there used to be some kind of protection, maybe in the form of a grating such as in VI 15, 3⁶: traces of lead were found fixed in the bottom directly next to the entrance, but these can also be related to an object filtering the wastewater flowing from the eastern branch of the discharge system.

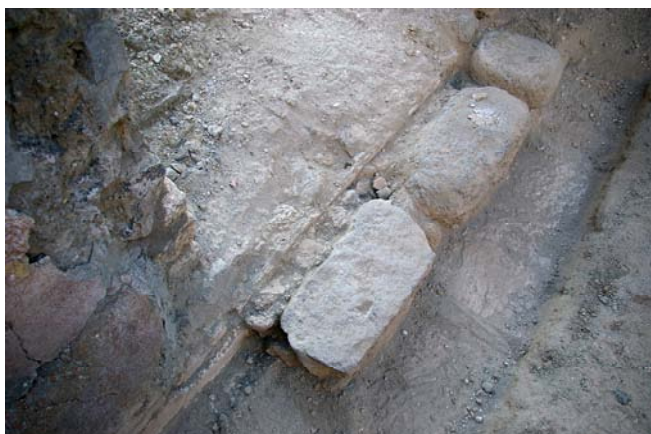
To surmount the difference in height between the shop and the *atrium*, a step was built in front of the door between the two rooms (Fig. 18). This step consisted of three reused basalt blocks placed directly on top of the floor of the room. Between the step and the door, it is possible to see traces of the plaster that covered the west wall before the door was made. The step probably was not covered by any form of plaster: no traces of it remain and the top layer of the new plaster covering on the wall, which is contemporary to the step, makes direct contact with the stones of which the step was made.

Fig. 18. Pompeii VI 14, 21-22: step in front of the door between shop 21 and atrium B.

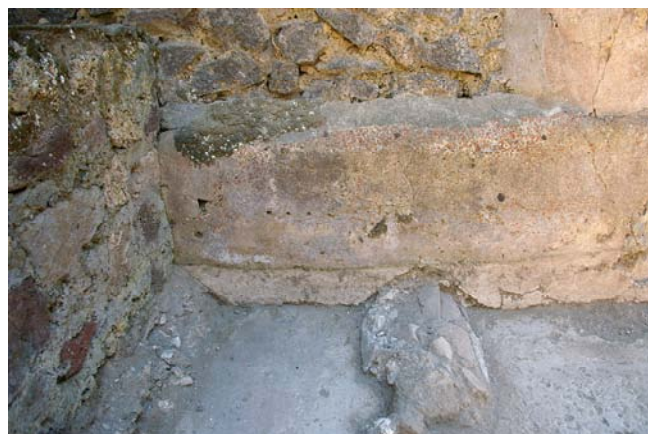
Fig. 19. Pompeii VI 14, 21-22, shop 21: W wall with remains of rim in front of the set of fulling stalls.

The three treading stalls along the south wall have suffered from a fallacious restoration carried out in the twentieth century, when a wall was built that closed off the openings in front of them. Several old pictures documented the situation before this happened. Each of the stalls had a high rim in its entrance and the area in front of them was surrounded by a lower rim that kept the rest of the workshop free from dirt. Whereas the rim in the entrances was overbuilt by the modern wall, the one surrounding the area in front of the stalls could be traced back (Fig. 19). This rim was made of rubblework covered by waterproof plaster. While little was left of the rim itself, it had left enough traces that allowed us to establish its course, running parallel to the stalls, but curving 90° southward in front of the easternmost stall and ending against the high rim in its entrance. This made it hard to reach the vessel in the platform east of the stalls without putting at least one foot on top of the rim or within the area it surrounded.

The rim plays an important role in the relative chronology of the house. It was placed directly on top of the *opus signinum* floor of the shop and belonged to a later phase in its history: some of the white *tesserae* randomly set into this floor could be found in places that had been covered by the rim. On the other hand, the rim was older than the youngest plaster on the west wall of the room, which suggests that the rim, and as a consequence the set of fulling

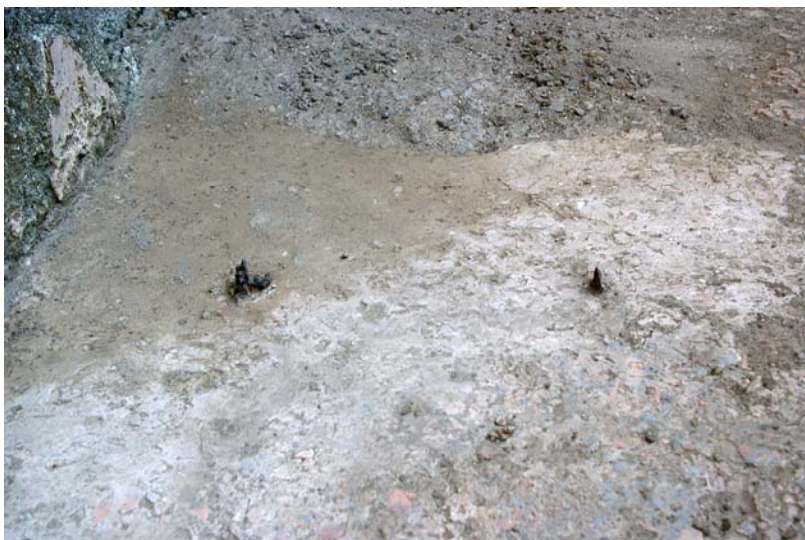
The floor of the shop is well preserved in large parts of the room, especially in the southern half. This part was completely cleaned and revealed two interesting features: the remains of some kind of installation and a figurative mosaic. The installation was situated east of the fulling stalls (Fig. 20). Its remains consist of two pieces of iron fixed in the *opus signinum* floor, at a distance of about 50 cm from the south wall. As there are no traces of disturbance to the floor, it is likely that the pieces belong to an ancient installation and not to some modern notice board. To what kind of object the pieces were connected is unknown, but it must be remarked that they may correspond to 6 small beam holes in the south wall that are all situated between the pieces of iron and the southeast corner of the room.

Fig. 20. Pompeii VI 14, 21-22, shop 21: pieces of iron fixed in the floor; remains of unidentifiable work installation.

Together, these may have formed some kind of rack over which clothes could be hung.

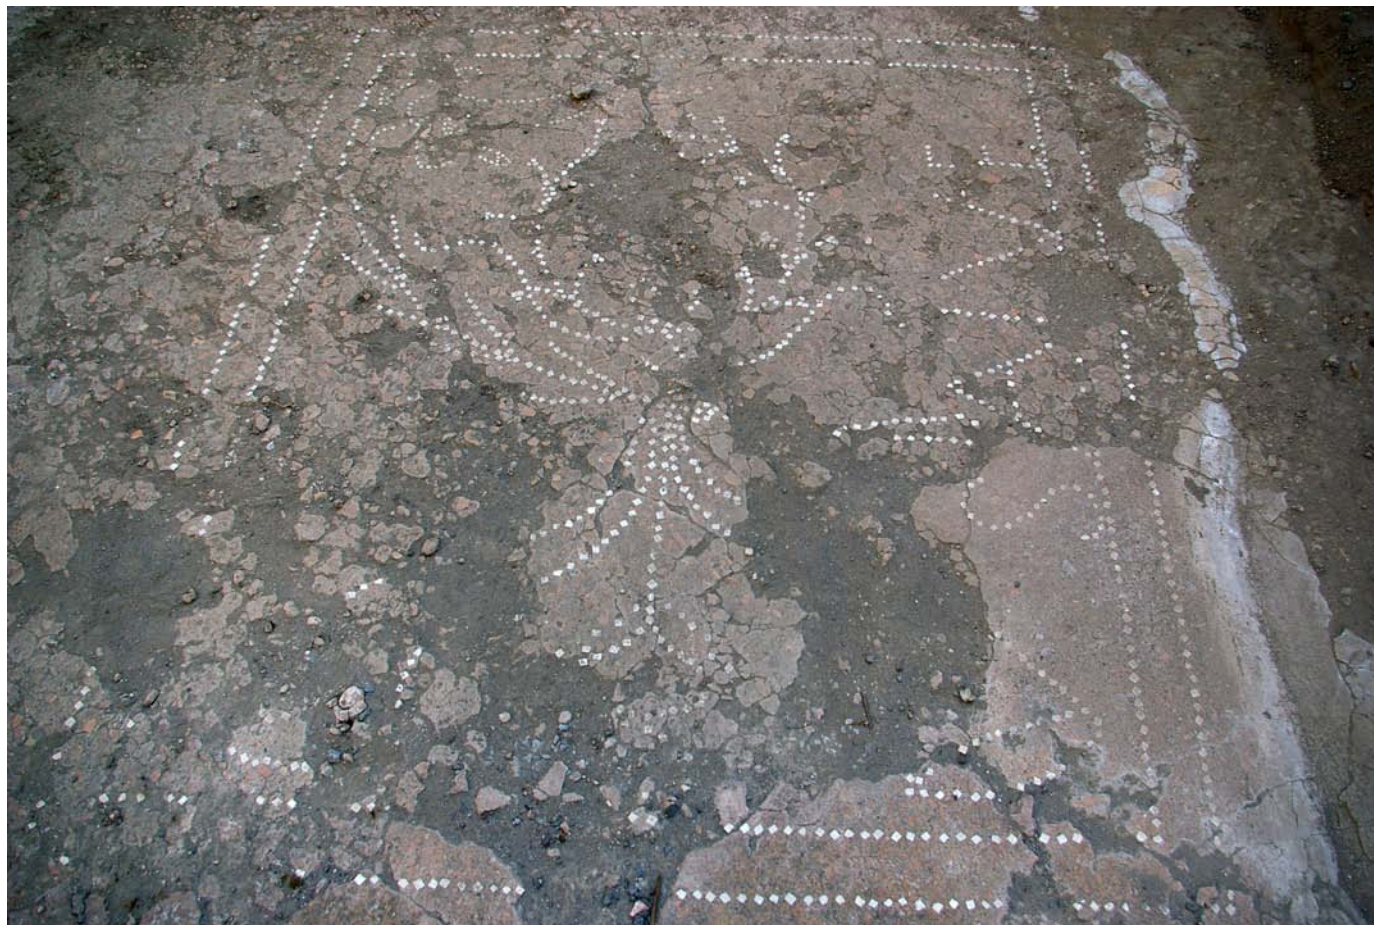
The mosaic was situated in front of the entrance and measured 155cm x 175cm (Figs. 21-22). It was made of

Fig. 21. Pompeii VI 14, 21-22, shop 21: mosaic of white tesserae in front of the entrance.

white *tesserae* pressed into the *cocciopesto* floor and it consisted of a set of iconographic symbols surrounded by a double rectangular frame. While short descriptions of the mosaic exist in late 19th century publications⁷ and in the CIL (X, 873), no scholar has discussed it more thoroughly and, except for a rather vague picture in Pernice's work on Hellenistic mosaics (Pernice 1938, 79), no photographic documentation has ever been published. There also was no drawing. The foremost half of the mosaic, directly behind the threshold, is occupied by an ensemble of two *cornucopiae* around a *caduceus*. This motif is known from several other contexts. A mosaic from the Casa delle Vestali (VI 1, 7.25), recently dated to the Augustan period, shows a polychrome version of it⁸. The combination of two *cornucopiae* and a *caduceus* also is a common motif on coins from the late republic onwards. Coins with these motifs have been minted by Marc Anthony (43 B.C.; RRC, Marcus Antonius 521; Cohen 66), Augustus (Cohen 219), Tiberius (RIC 1, Tiberius 28) and Claudius (Cohen, p. 265). Compared to these coins, the ensemble in the mosaic from VI 14, 21, remarkably, appears to have been depicted upside down: normally, the wider end of the *cornucopiae* and the top of the *caduceus* formed the top of the scene. Directly behind the *cornucopiae*, over the entire width of the mosaic, some kind of branch is depicted. It is slightly curved in upward direction and has short side branches or leaves on both sides that lie close to the main branch. The iconography is similar to that of palm branches on coins, which often, though not always, are depicted with a similar curve (e.g. RIC 1, Augustus, 145 [17 B.C.]). Behind the palm branch is a wreath made of small twigs held together by strings tied in a bow. The twigs have many short side branches on both sides that grow away from the main twig and end in triangles of *tesserae* that maybe represent buds. It is not clear what plant species is depicted. Laurel and olive, of which the leaves grow directly from branch, seem improbable. Neither is the other common option, oak, likely, as Roman depictions of oak wreaths, which were symbol for outstanding citizenship, usually are dominated by the leaves and not by the branches of the oak twigs. However, the symbol of the wreath in itself is powerful enough to be independent of plant species. Like the other elements of the mosaic mentioned thus far, wreaths often appear on coins. Next to the wreath, in the upper left corner of the mosaic, two winged phalluses are depicted: a large one in erect state and below that a smaller one in a normal state. Finally, along the right side of the mosaic was the word SALVE (CIL X, 873), with its letters laid directly next to the border of the mosaic and oriented towards the north wall of the room. The mosaic is unique and there are no close parallels, neither in Pompeii, nor elsewhere. This makes interpretation hard, but it may be argued that the symbols depicted all are related to successful profit-making: the *cornucopiae* with the *caduceus*, the palm branch and the wreath all make regular appearances on coins and depictions of phalluses are common in Pompeian workshops, for example above the ovens of bakeries. They may be seen as an apotropaic symbol of fertility protecting the shop's good fortune. Thus, while the mosaic does not tell one clear story, it makes eclectic use of an iconography hinting at commercial success.

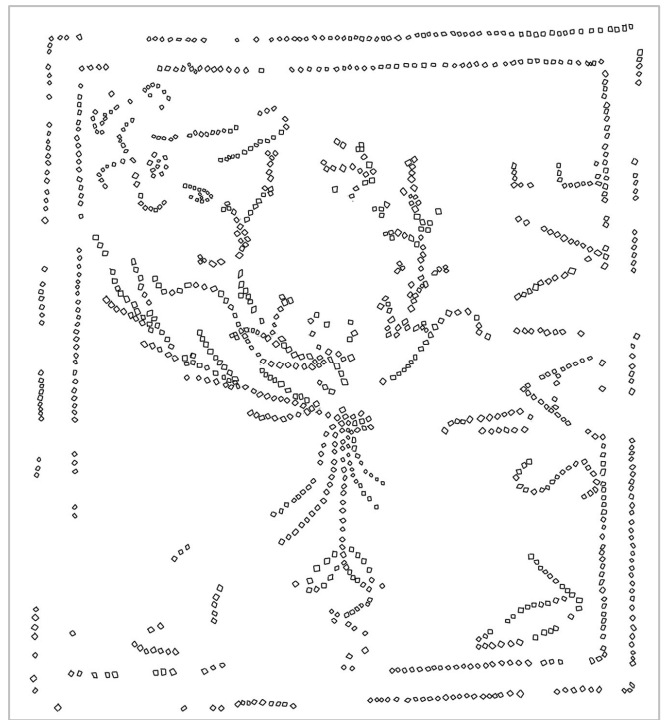
Fig. 22. Pompeii VI 14, 21-22, shop 21: mosaic. (drawing: C.W. Verburg, M. Flohr).

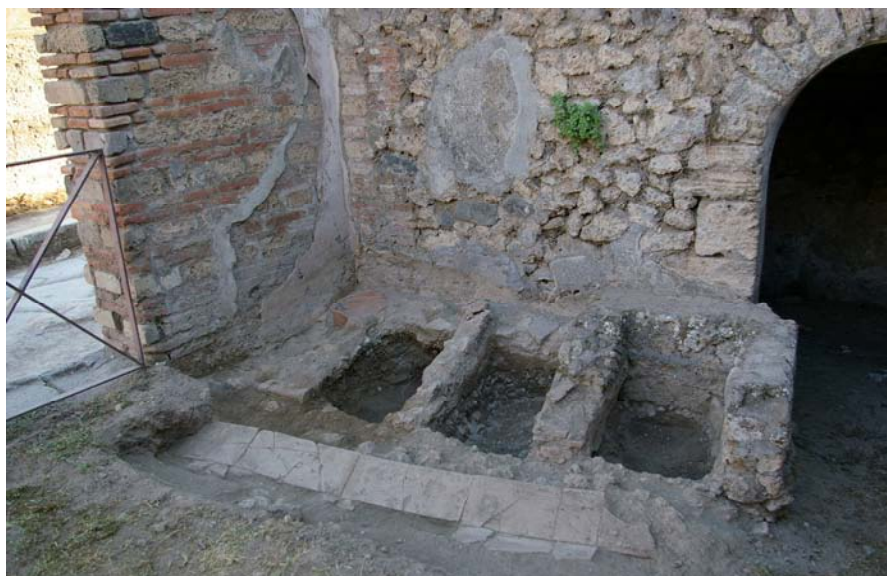
scholars began to doubt their identification¹³. However, surface cleaning in this part of the shop revealed that Della Corte and Moeller were right: there was a row of three fulling stalls (S1-S3) along the west wall (Fig. 24). In the southwest corner was a *podium* that contained two immured amphorae (A1-A2), of which the bottoms have been preserved *in situ* (Fig. 25). In front of the stalls was a gutter. This ensemble includes all the typical elements of the small Pompeian *fullonicae*: stalls, storage-vessels and a provision to separate the wet area with the fulling stalls from the dry parts of the workshop.

The stalls are slightly below average in size. S1 and S2 probably must be seen as 2½'R deep and 1½'R wide, whereas S3, which has thicker walls, had an internal depth of 2¼'R and a width of about 1¼'R (the dimensions were: S1: W: 42cm, D: 73cm; S2: W: 43cm; D: 74cm; S3: W: 50cm; D: 64cm). The walls between and behind the stalls used to be covered with waterproof plaster and there were beds of *opus signinum* surrounding the fulling tubs, but little of these remains nowadays. Only in the southwestern part of S1, traces of the embedding of the tub could be discerned. They consisted of a layer of fine plaster over a coarse bed in which pottery sherds had been placed. A similar bed was found in *fullonica* I 4, 7¹⁴. There might have been a rim in the entrances of the stalls, but little of it remains. The position and layout of the *podium* with the two amphorae is remarkable. It is situated in the corner of the room, so that only the worker in S1 could take chemicals from the amphorae without having to leave his fulling stall. Further, while amphora A2 was placed in front of the *podium* and easily reachable for anyone approaching, amphora A1 is situated against the back wall and could only be reached by leaning over or stepping into S1. Remarkably, there is about 20cm of empty space between the amphorae, so it would have been possible to give the amphora a more accessible position. Possibly, the space between the amphorae was left free so that the fuller had a place to put his right hand. In any case, the organization of the three stalls meant that the fuller working in S1 had a privileged position as he was not only the only one having direct access to the amphorae but also could control the access of the other workers.

The gutter in front of the fulling installation was made of reused roof tiles. These were cut into pieces of 20x45cm, which were pressed into a bed of mortar with their flat sides up. The tiles were placed in two rows next to each with their long side parallel to the west wall. Both rows were slightly sloping towards the middle of the gutter. Of the western row, four tiles and part of a fifth has been preserved, but the eastern row is almost completely gone, except for some fragments of tiles. The southernmost part of the gutter, near the door of the shop, could not be traced because of the concrete foundations for the modern fence. However, a terracotta pipe visible in the border of the sidewalk, precisely in front of the gutter, suggests that wastewater could be disposed of through a small drain.

Fig. 24. Pompeii VII 2, 41, shop: fulling stalls, overview with drainage channel.

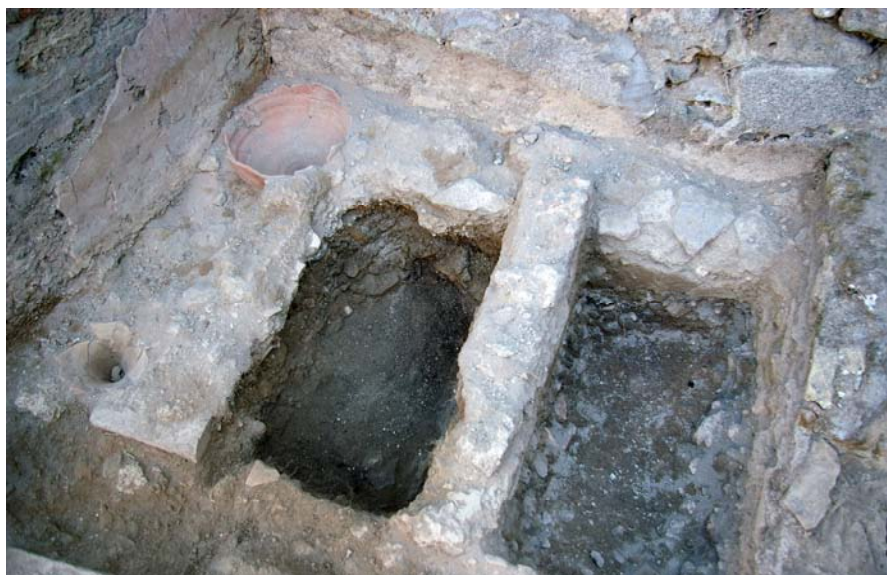
Fig. 25. Pompeii VII 2, 41, shop: fulling stalls, SW corner with remains of two amphorae.

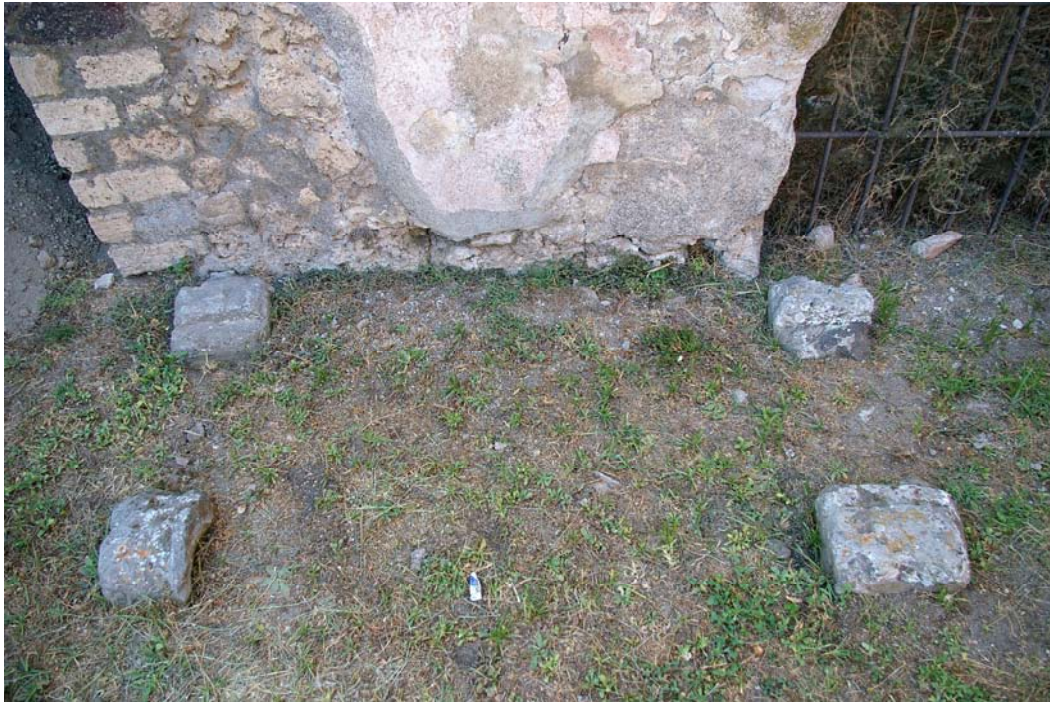
The other installation stood in the east part of the shop along the north wall (Fig. 26). Its existence is indicated by four blocks of lava stone, which probably formed its foundation. Three of the blocks were similar in size and shape. They were rectangular (23-24cm x 24.5-28cm), with their longer sides parallel to the north wall. Their inner sides had been slightly cut away so that the installation could be fixed between them. The southwest block is smaller and seems slightly out of context. Two shallow holes in the north wall are possibly related to these four blocks.

These holes are about 2.70m above the floor, below the ceiling, and they may have been connected to the upper part of the installation, so that it stood stable. The installation had a width of 6 RF and a depth of 3 RF (measured dimensions: width 180cm, depth 91cm). These dimensions and the care taken in giving the installation a stable and fixed position may suggest that it was a fulling press. In those workshops where actual remains of a press were found, such as I 6, 7 and VI 14, 21.22, excavators also noted that these remains were securely fixed in the wall or in the floor.

Fig. 26. Pompeii VII 2, 41, shop: blocks of lava stone forming the basis of an installation.
